Performance of a 3-Storey RC Structure on Soft Soil in the M6.4 Lefkada, 2003, Greece, Earthquake

SUMMARY

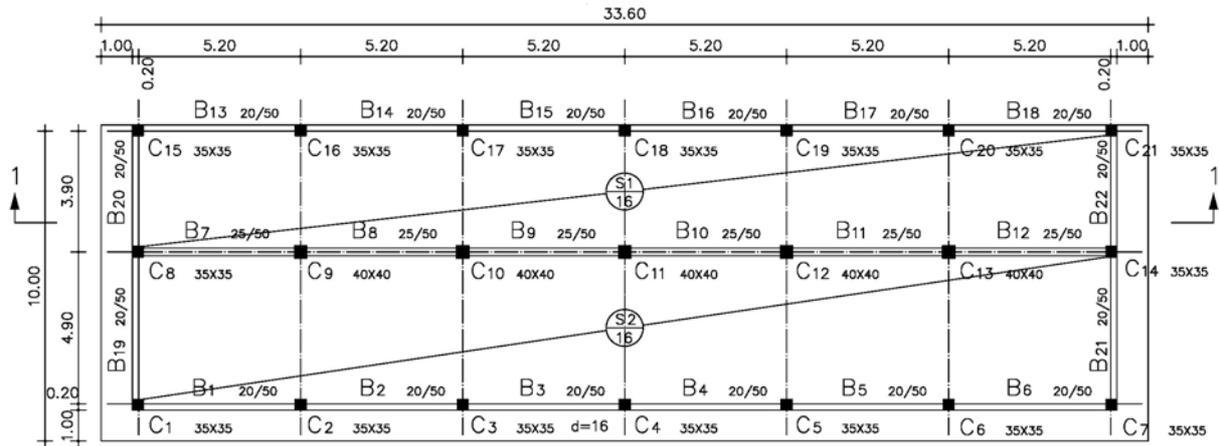
Figure 6: Plan view of typical floor

Observed column damage was concentrated at the heads of columns on the first and second floor; severity varies from light (columns C1, C2, C21 of the 1st floor and C1, C6, C7, C8, C9, C10, C21 of the 2nd floor) to serious (C9, 1st floor and C2, C15, C19, C20, 2nd floor). Nevertheless no total member failures were observed, which can be attributed to sufficient ductility capacity of the columns.

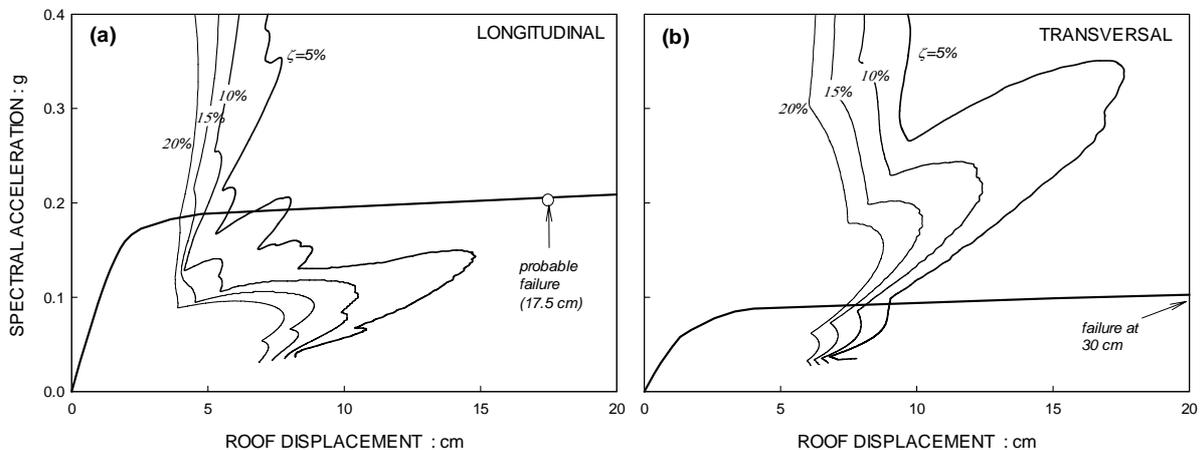
Figure 10: push-over diagrams and demand curves for the two orthogonal directions of the building.

Regarding the “strong” L direction (Fig 10a), the base shear corresponding to the elastic point is $V_{el} = 0.185W$ at a roof displacement of 1.9cm. The failure point is located at $V_{\max} = 0.206W$, at a roof displacement of 17.5 cm,

overstrength $q_o = 1.10$. Hinge failures start to develop at a roof displacement of approximately 4.8cm at certain columns of the 1st and 2nd storeys, including the ones that were actually damaged. Note that in most cases, formation of plastic hinges is related to reduction of the cross-section of the columns at the slab separating the 2nd and 3rd floors. As can be seen from Fig 10a, seismic demand in this direction is about 4 to 5 cm, which suggests permanent damage but no collapse.

With reference to the “weak” T direction, base shear corresponding to the elastic point is $V_{el} = 0.086W$ at a roof displacement of 1.7cm, whereas failure point is located at $V_{max} = 0.11W$, at a displacement of 30cm. This results to a system ductility capacity $\mu^{(T)} = 30/1.7 = 19$ and an overstrength $q_o = 1.28$. Plastic hinges start to appear at a displacement of 15 cm. As can be derived from Fig 10b, seismic demand in this direction is 9cm so, obviously, at this point there is also permanent damage.

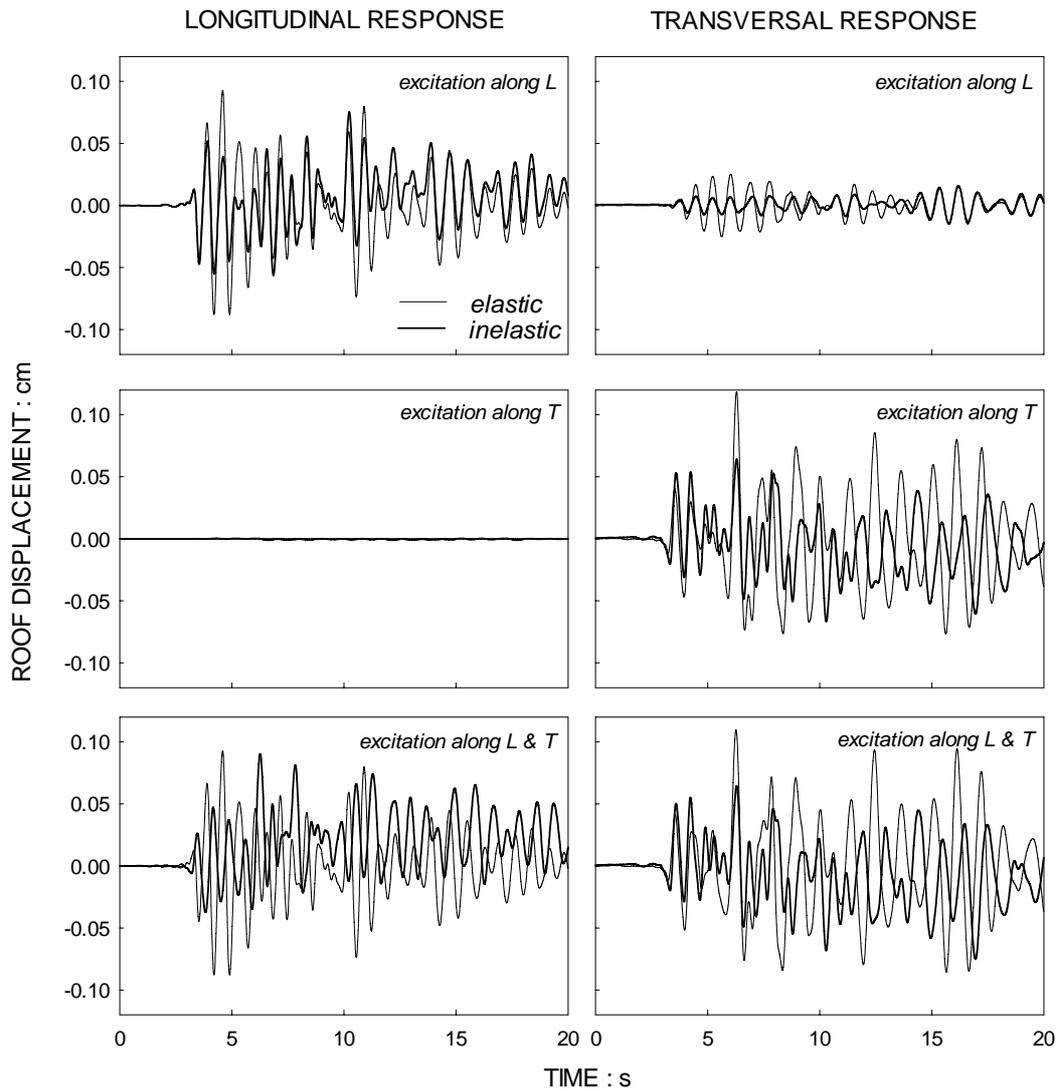
Figure 11: Roof displacements at C1 using 3D non-linear dynamic analyses for different excitations.

To develop additional insight on the performance of the structure, non-linear time history analyses were performed, both for fixed-base and flexible-base conditions. The member properties employed are consistent with those used in the spectral and pushover analyses. Three excitation options were considered: (1) excitation along L direction only, (2) excitation along T direction only, (3) simultaneous excitation along L and T. To this end, the horizontal components of Lefkada Hospital recording were rotated 70° clockwise to conform with the orthogonal directions of the structure. A typical result from these analyses is presented in Figure 11. It is observed that: (1) Dynamic response along L and T directions is practically uncoupled. The trend becomes stronger for inelastic conditions. (2) Peak displacements in the two directions is practically equal (about 10cm). (2) Displacement demand is similar (though not identical) to that predicted by the simplified push-over analyses (3) Elastic and inelastic displacements are comparable in all cases. (4) Response considering excitation only along the L or T direction is comparable to that for simultaneous excitation along the two orthogonal axes. (5) No significant residual offset is observed – in accordance with observations. Overall, the simulations are
