THE HAMAM OF IOANNINA: ANALYSIS AND RESTORATION

C. Giarlelis, P. Kremezis, C. Spanos
Consulting Engineers, OMETE SA, Athens, Greece

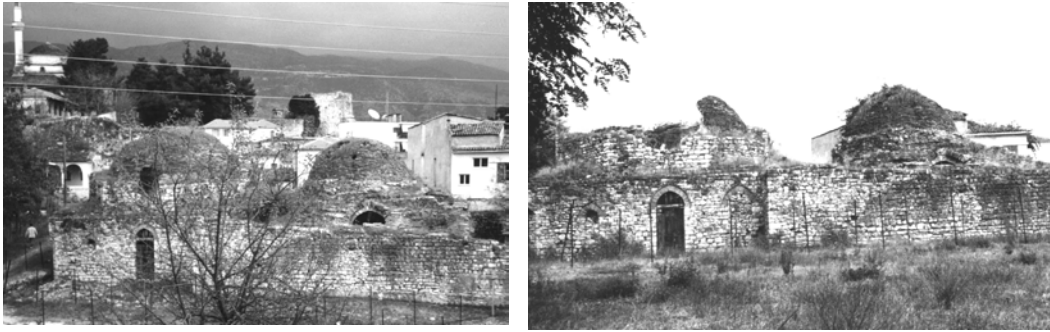
Figures 1a, 1b. Monument before and after the collapse of the soyunmalik dome.

The monument has been abandoned for many years and is in a ruined condition (Figs. 1b, 2a, 2b, 3). The damages that it has endured can be attributed to weather conditions (humidity and rainfall) and earthquakes. Also, due to the complete lack of maintenance, its condition is rapidly deteriorating. After a thorough structural inspection, carried out by the authors, the pathology was recorded. Structural damages can be divided into two categories: (1) damages of general nature, concerning the disruption of continuity and shape of the structural system (partial

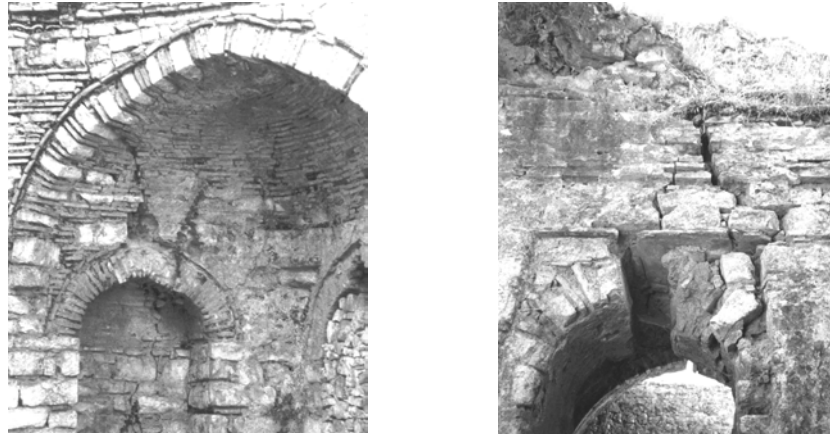
Figures 2a, 2b. Damages at domes and arches.

collapses, extensive cracks) and (2) localized damages concerning the deterioration of building materials (masonry, bricks, mortar).

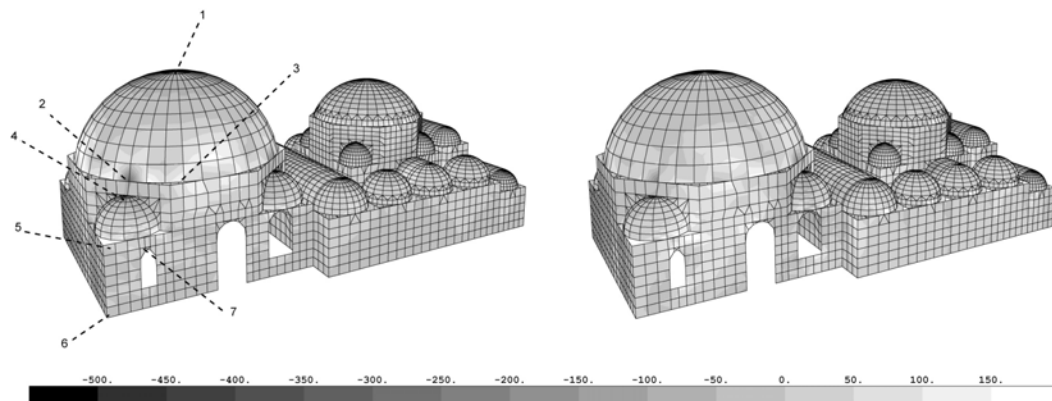
be concluded that compressive stresses are small compared to the strength of masonry. This is not the case with tensile stresses that exceed the capacity of the structure at several points, especially on the upper part of the large domes of soğukluk and sıcaklık. On Figs. 5a and 5b, the vulnerable areas of the structure are denoted. In Table 3, normal stresses, parallel and normal to bed joints, S_{11} and S_{22} respectively, on selected points of the structure, denoted on Fig. 5a, are presented. As can be derived by comparing Figs. 5a and 5b to Fig. 3 the results reveal the weak areas of the monument and give an accurate account of the actual partial collapses and cracks. This shows the validity of the model used, crucial to continue to the next stage and also proves that despite the growing use of inelastic methods, elastic analysis can still be a sufficient tool.

Figures 5a, 5b. Original Structure: maximum principal stresses (KPa) from gravity and seismic loads respectively.

and using tie-rods. The latter, after taking into account the results of the analysis of the original structure, are placed on the octagonal base of the major domes and on the crown of the perimeter walls. To determine the best restoration proposal, analyses were performed on a series of structural models, gradually increasing the degree of intervention, by adding tie-rods. The final proposal, presented here, corresponds to the minimum possible intervention. The reinforcement does not affect noticeably neither the stiffness nor the mass of the structure, so the fundamental period is the same as in the previous analysis. Principal stresses S_{\max} are presented on Figs. 6a and 6b for gravity and seismic load combinations respectively. In Table 3, normal stresses, parallel and normal to bed joints, S_{11} and S_{22} respectively, on selected points of the structure, denoted on Fig. 6a, are presented. It can be concluded that tensile stresses, still located in the same areas of the monument as in previous analysis, have decreased by 10% approximately.

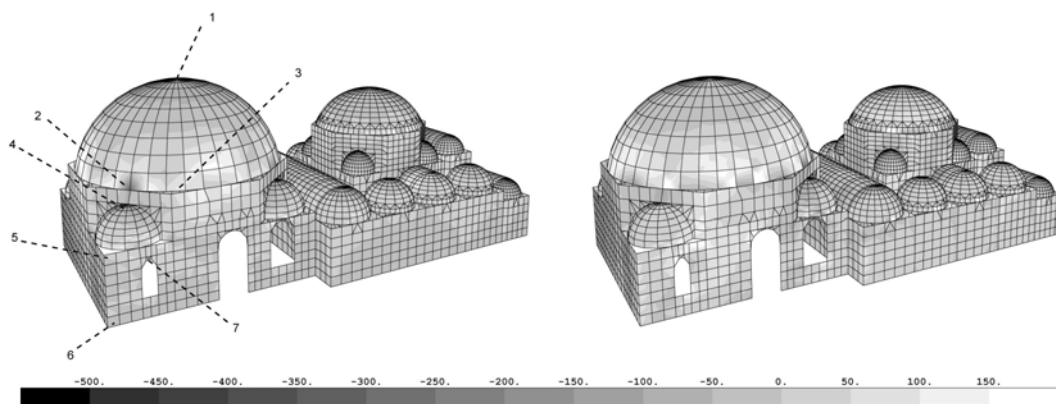
In order to further investigate the behaviour of the monument and check the performance of the reinforced structure, analyses under selected motions of Greek territory (Table 2), were carried out. These motions impose greater actions than the provisions of GSC-2000. Response spectrum analysis using the records of Athens (1999) and Kalamata (1986) earthquakes result in tensile stresses that slightly exceed the strength of the masonry. This is not the case with the severe Egeon (1995) earthquake; tensile strength of masonry is surpassed and therefore inelastic analysis would be needed as a further step to predict the monument's behaviour.

Figures 6a, 6b. Reinforced structure: maximum principal stresses, (KPa), from gravity and seismic loads respectively.
