# **The M6.5, Nov 17th 2015, Lefkada earthquake Reconnaissance Report**

**Christos Giarlelis, Christos Boutsoras  
Structural Engineers**

**December 2015**

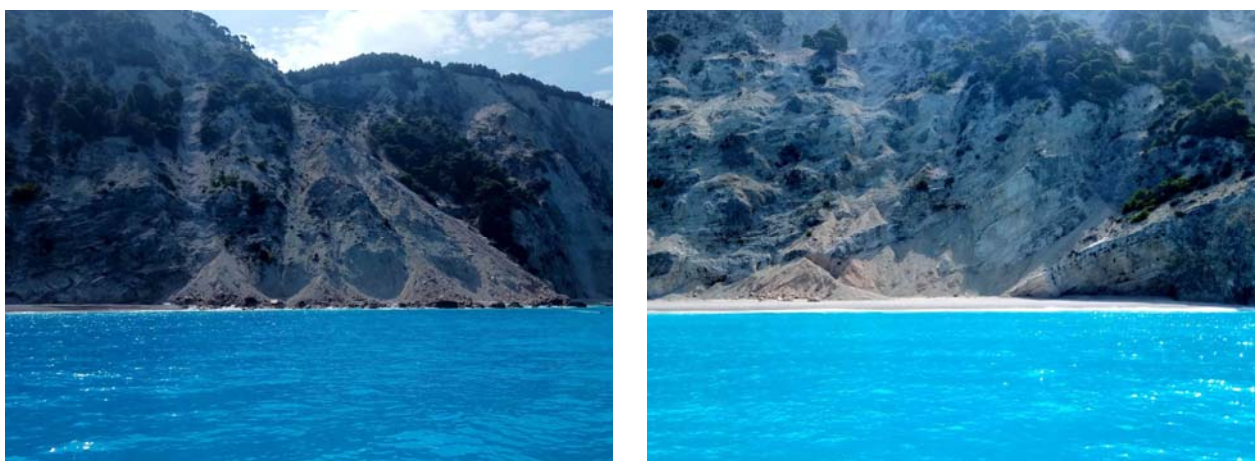
As has been already mentioned, the dominant type of the earthquake-induced failures was rockfalls and landslides that affected the southwest part of the island. The most severe slope failures took place along the coastline from Porto Katsiki to Ag. Nikitas and especially the Egremnoi beach (Figs 3.1a, b).

**Fig 3.1a, b** Debris slide and rockfalls along the the coast of Egremnoi

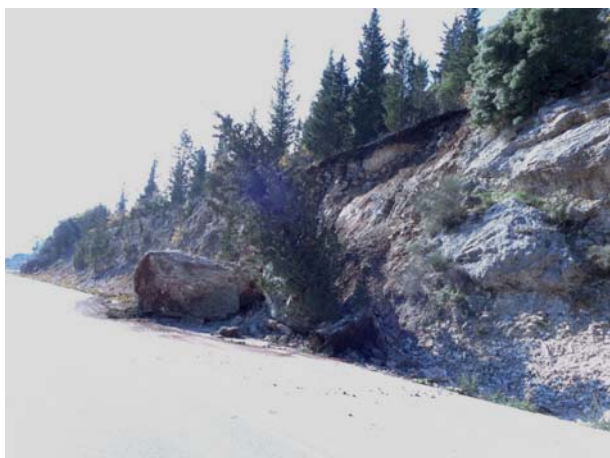
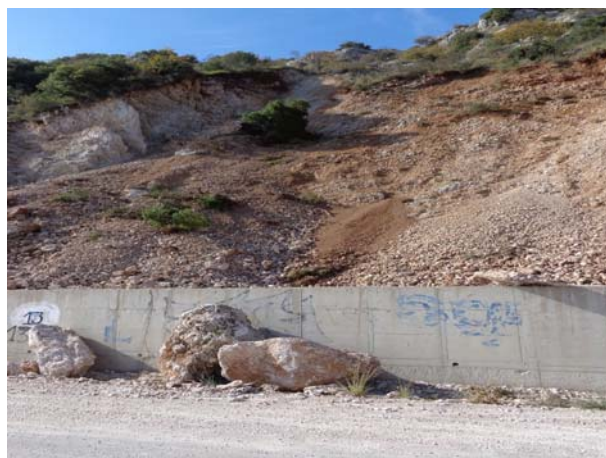
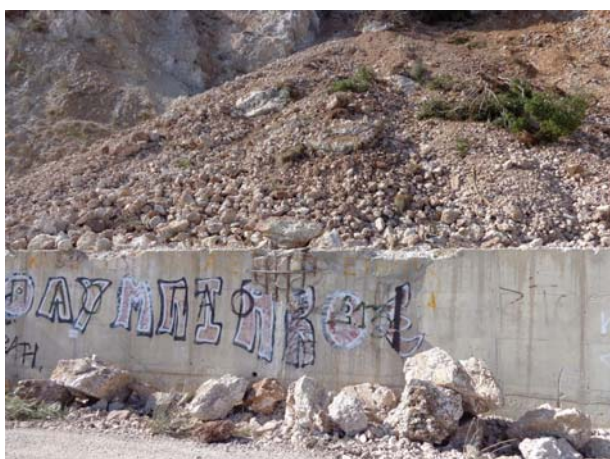
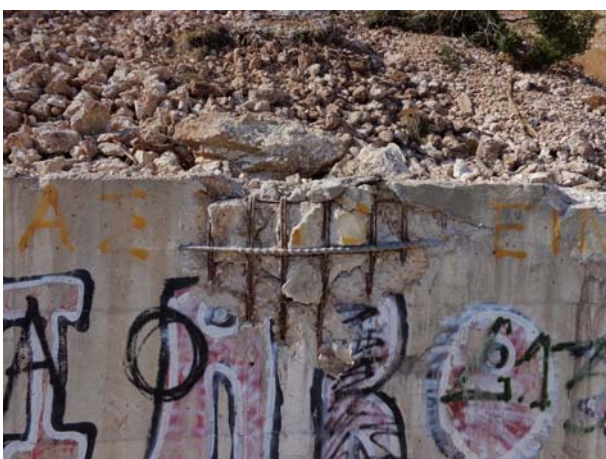
Also extensive rockfalls triggered by the earthquake took place along the road from Vassiliki to Agios Petros with displaced rocks of a size up to 3m (Figs 3.2a, b). At some places the mitigation measures consisting of retaining or restraining structures (retaining walls and rock curtains) failed due to the impact (Figs 3.2c, d). Overall the mitigation measures over the road network can be considered as effective preventing a larger catastrophe.

**Fig 3.2a, b, c, d** Earthquake-induced landslides along the road from Vassiliki to Agios Petros.

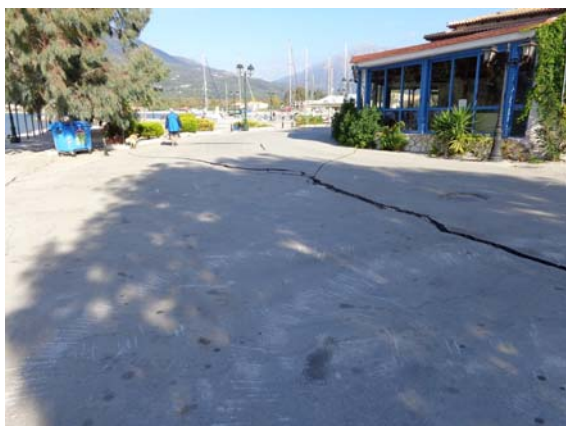
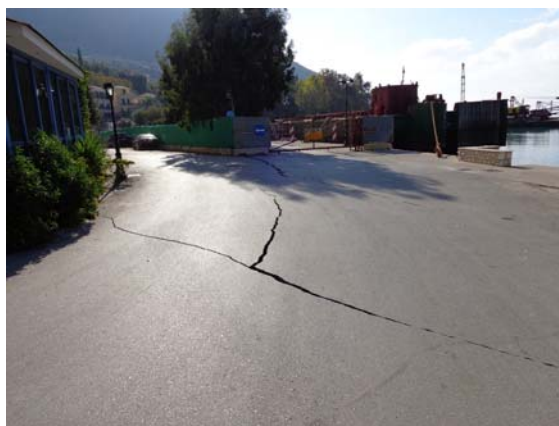
The earthquake induced damages to the waterfront area of Vassiliki. The recently constructed pier and quay wall experienced displacement that possibly led to road cracks and small settlements at the

**Fig 4.1a, b** Road cracks at the waterfront area of the port of Vassiliki.

waterfront area. We found no visible evidence of liquefaction however careful studies should determine if liquefaction actually took place.

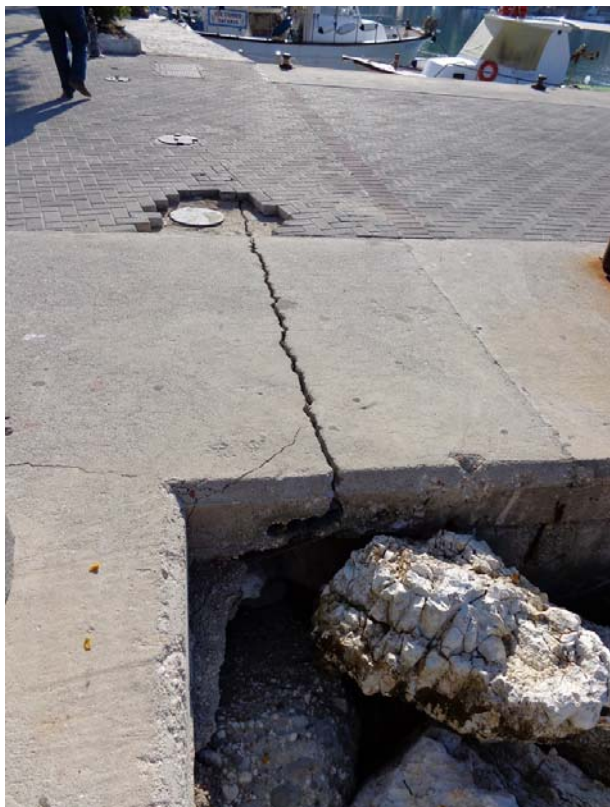
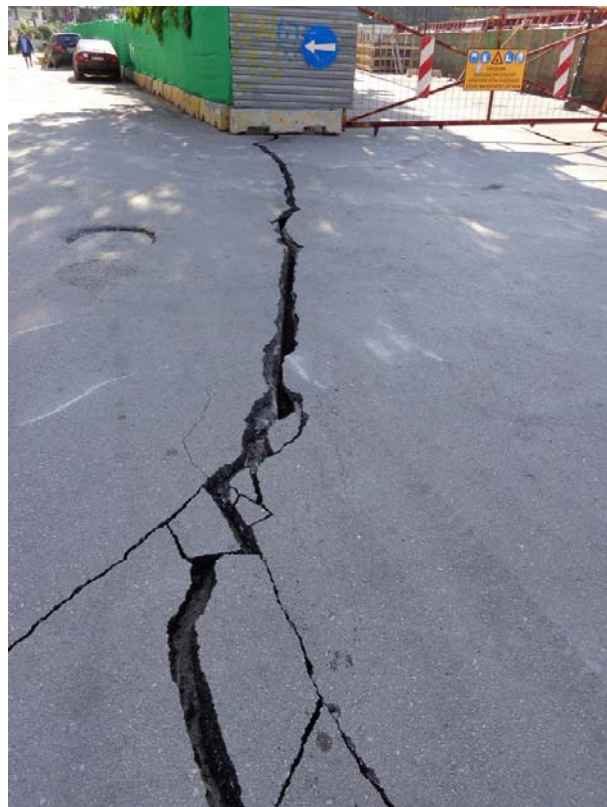
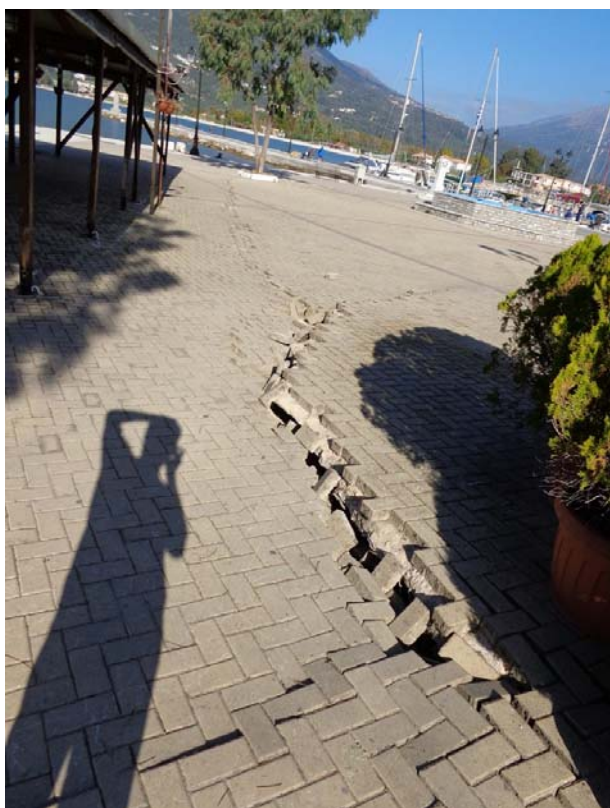
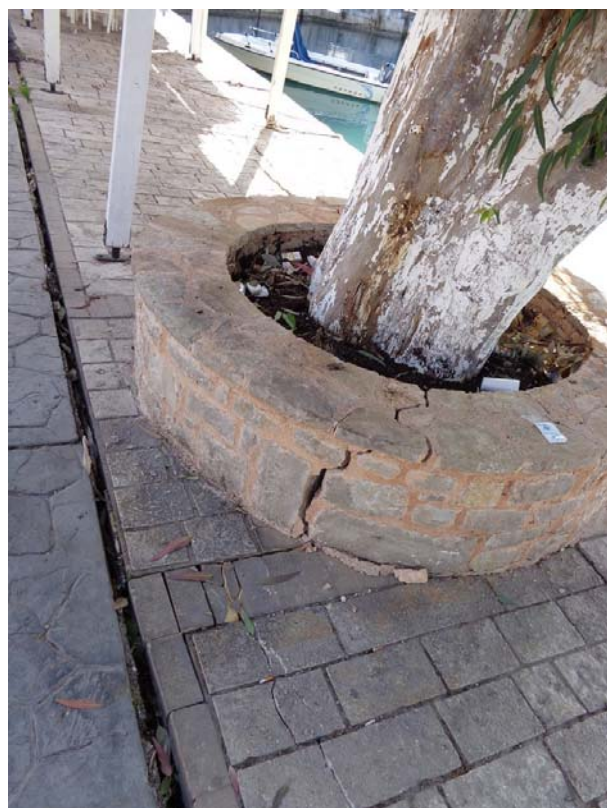
**Fig 4.2a, b, c , d** Displacement of new quay wall - cracks at the waterfront area of the port of Vassiliki.

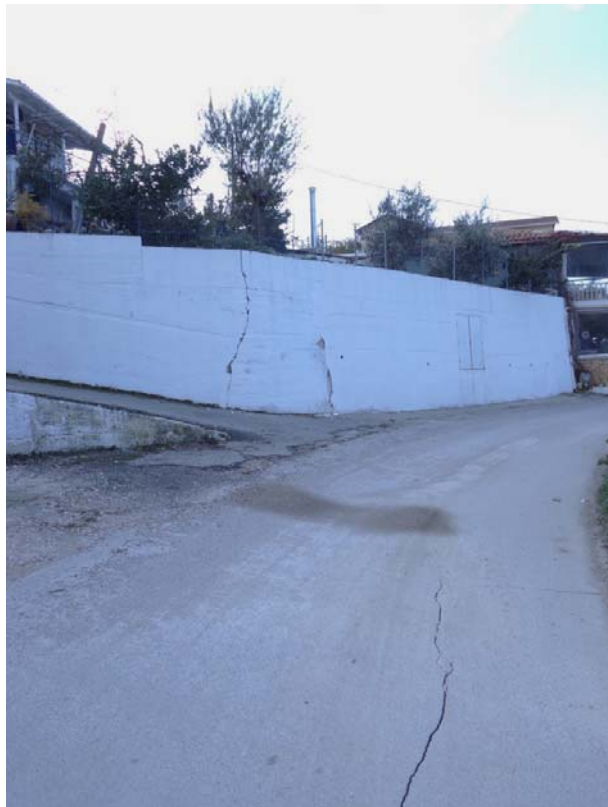
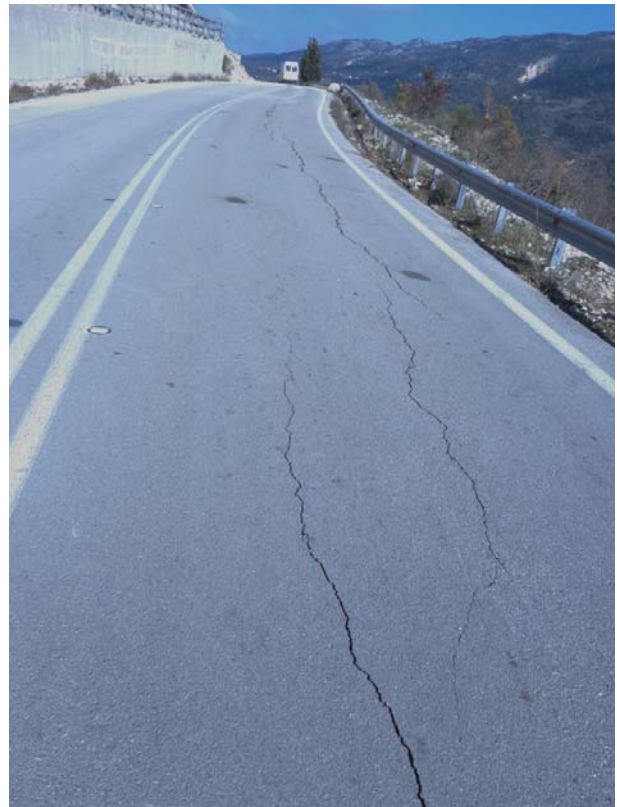
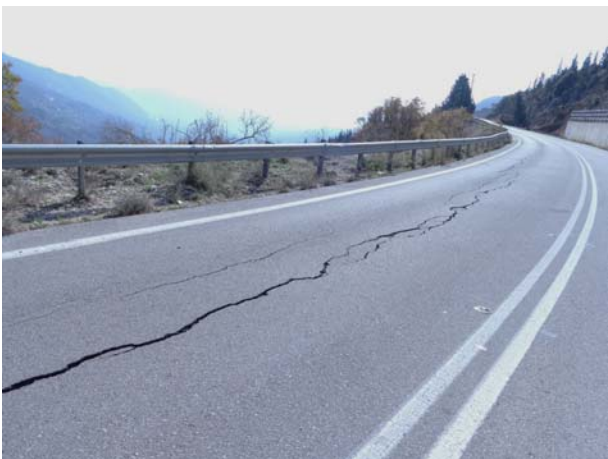
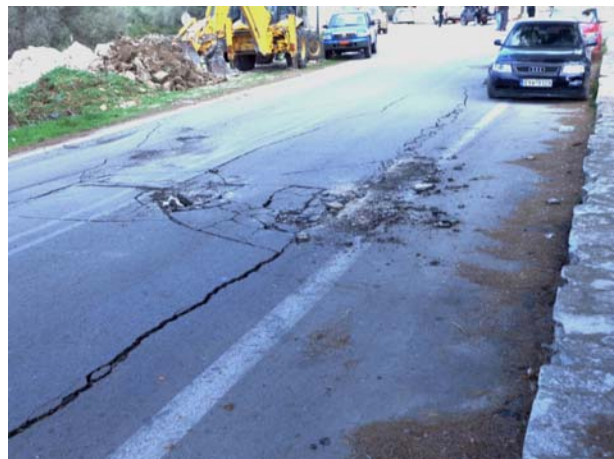
The extensive cracks at the southwest part of the island's road network were a major damage in terms of cost and can be attributed to slope movement or fill settlement (Figs. 5.1 a, b, c, d and 5.2 a, b, c).

**Fig 5.1 a, b, c , d** Asphalt cracks due to slope movement (a, b,c) or fill settlement (d).

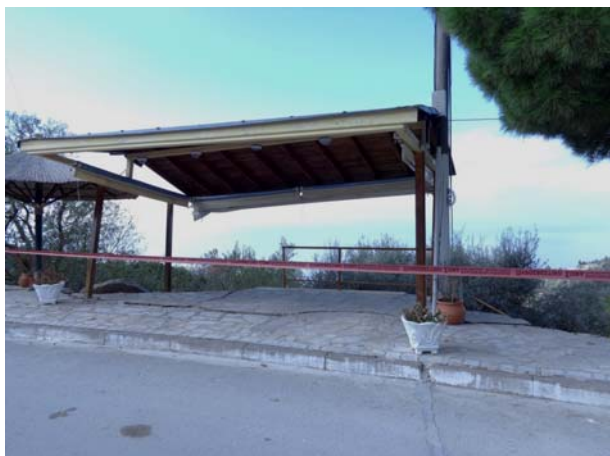
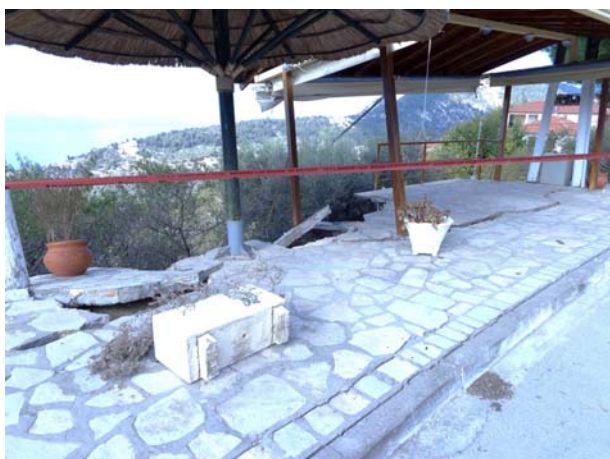
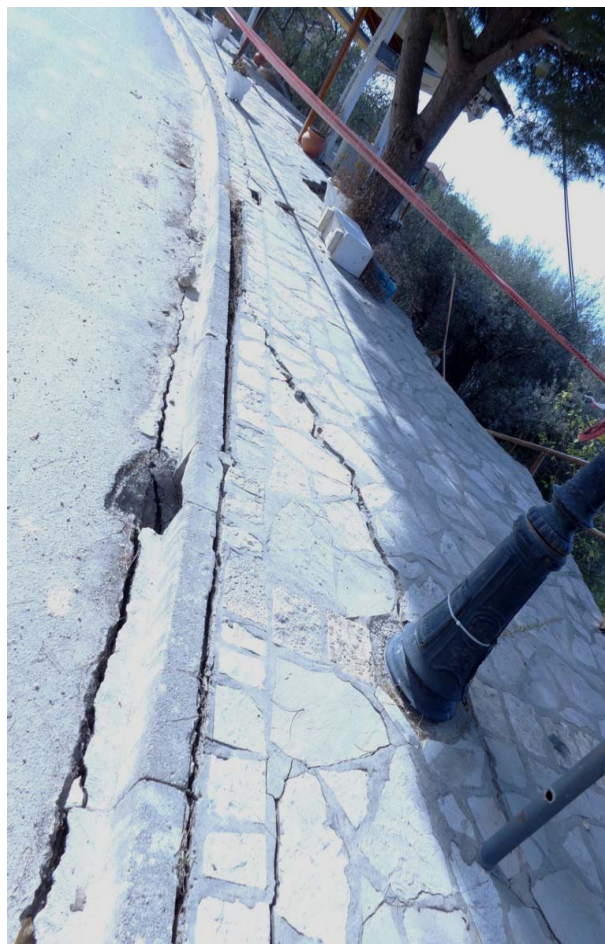
**Fig 5.2 a, b, c** Asphalt cracks due to slope movement.

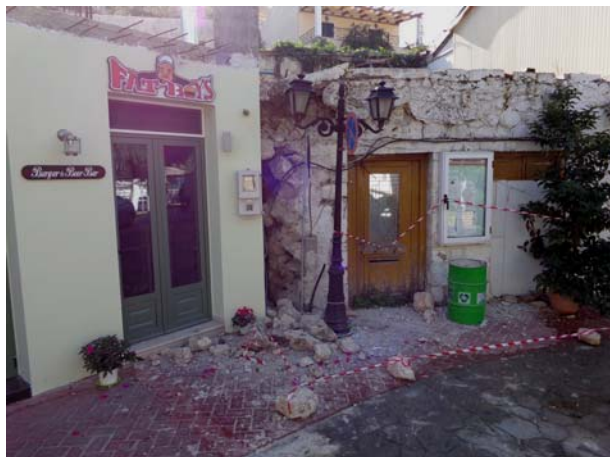
In the villages of the southwestern part of the island, near the epicenter, several old masonry buildings sustained serious damage (Figs 6.1, 6.2). Characteristic is the collapse of the Agia Paraskevi church at Athani a historical structure built in the 18th century (Figs 6.3a,b). However most of these old buildings avoided collapse. A possible explanation is that the actual strength of traditional structures in the area (built using an ingenious combination of masonry and wood) is unusually high due to local design traditions (low weight, overstrength) [4]. Also it should be mentioned that geotechnical failures such as settlements may have contributed to some of the failures.

**Fig 6.1** Damaged old masonry building at Vassiliki.

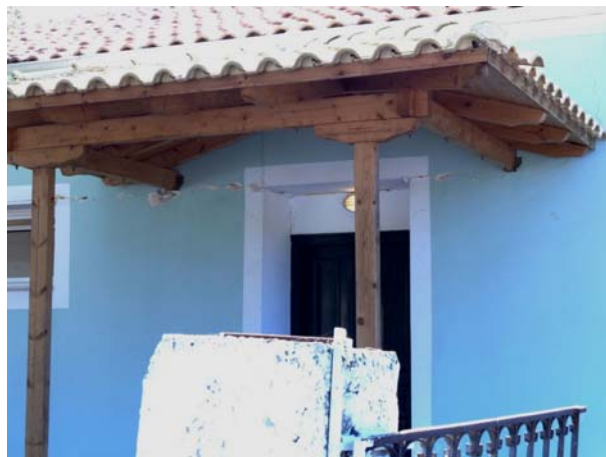
**Fig 6.2** Horizontal cracks around the openings of a masonry structure.

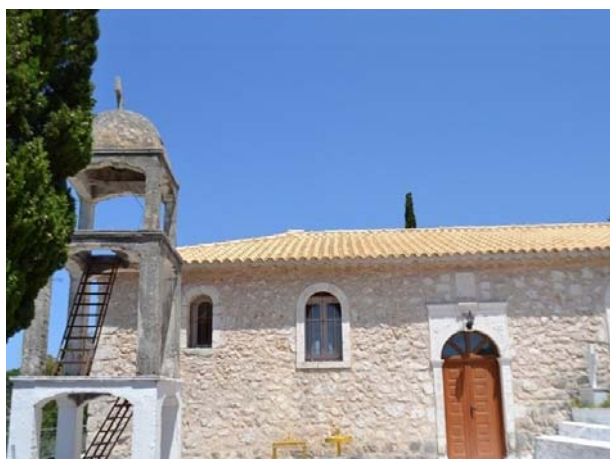
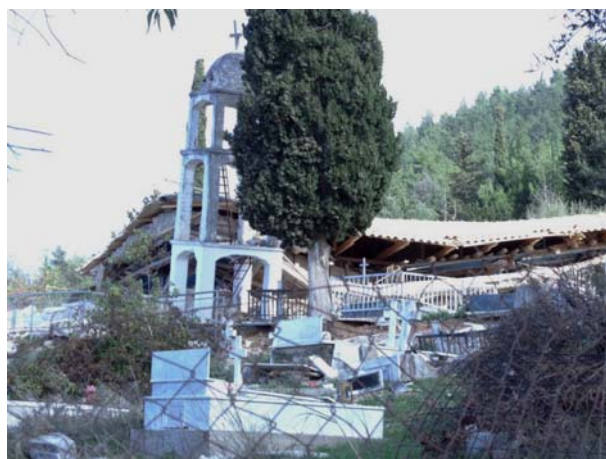
**Fig 6.3a, b** The Church of Agia Paraskevi at Athani before and after the collapse, respectively.

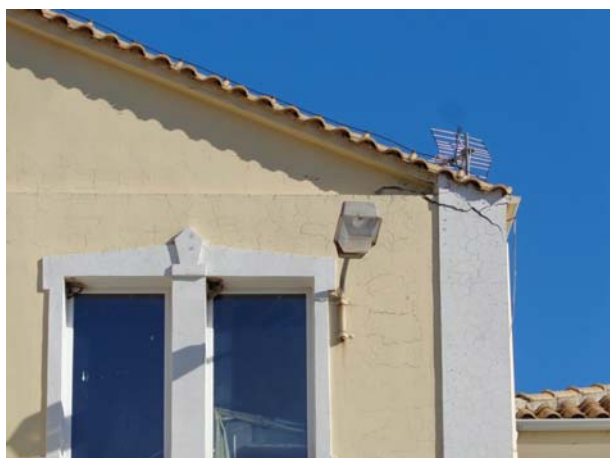
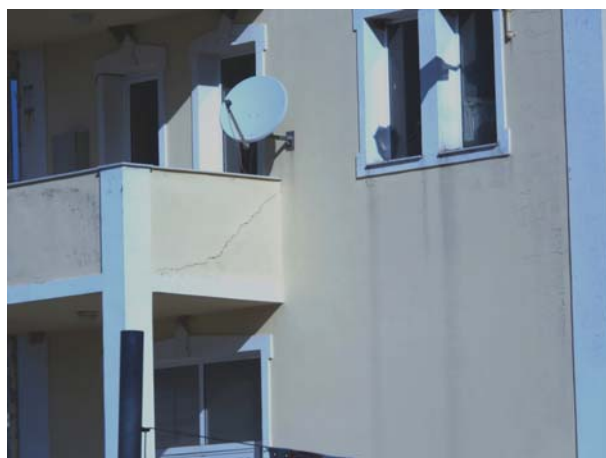
New reinforced concrete structures experienced minimal damage usually concentrated at the columns' head of the top floor under the roof (Figs 6.4a,b, 6.4, 6.6). The uplift and dislocation of roof tiles was widely observed along with cracks on masonry infillwalls (Figs 6.7a,b,c,d). The latter is a proof of the high, earthquake induced, vertical accelerations at the epicenter area.

**Fig 6.4a, b** Cracks at the column's head of the top floor under the roof and at the balcony parapet of the RC school building at Vassiliki.

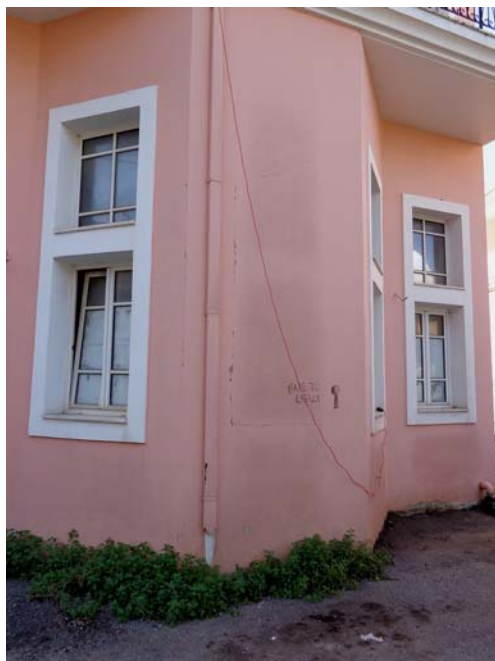
**Fig 6.5.** Detachment of an infill wall from the surrounding RC frame at a two-storey building in Vassiliki.

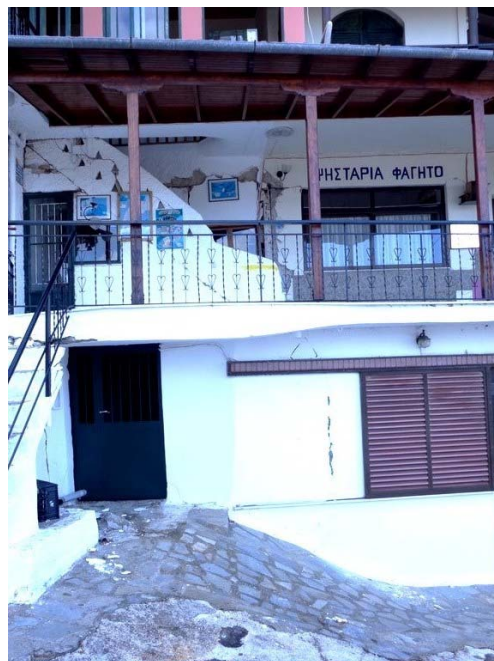
**Fig 6.6.** Horizontal and vertical cracks on the infill walls of a building at Athani.

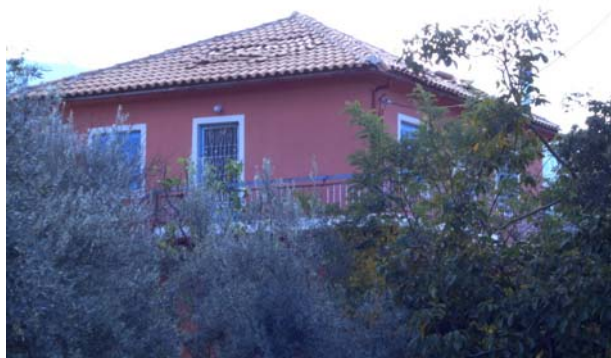
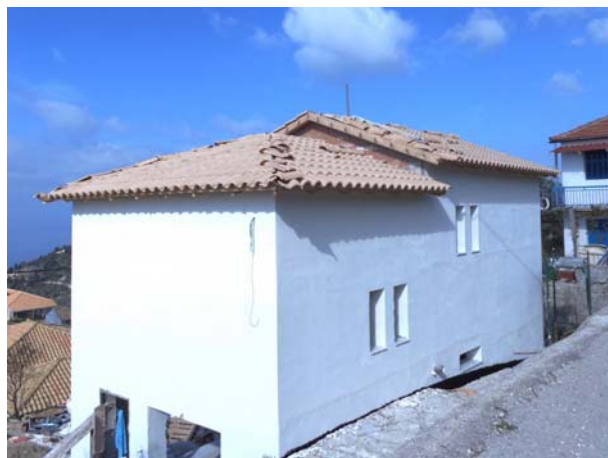
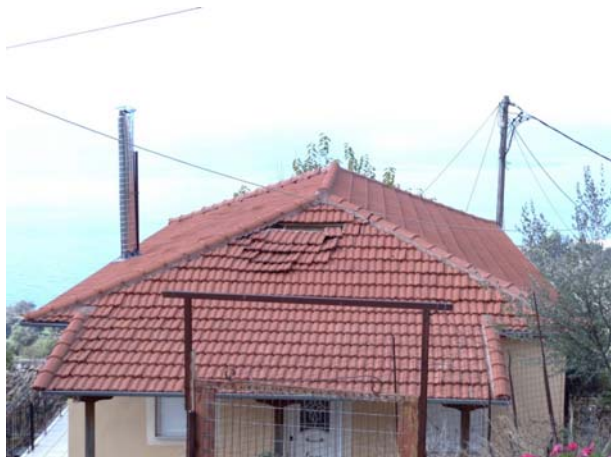
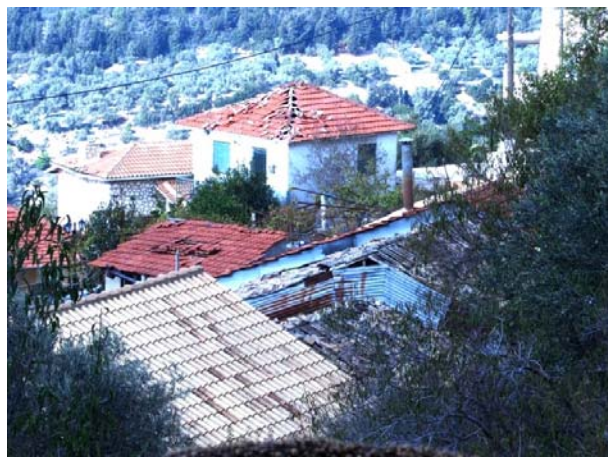
**Fig 6.7a, b,c,d .** Uplift & dislocation of roof tiles of residential buildings at Dragano (a) and Athani (b,c,d).
