Performance of a 3-Storey RC Structure on Soft Soil in the M6.4 Lefkada, 2003, Greece, Earthquake

SUMMARY

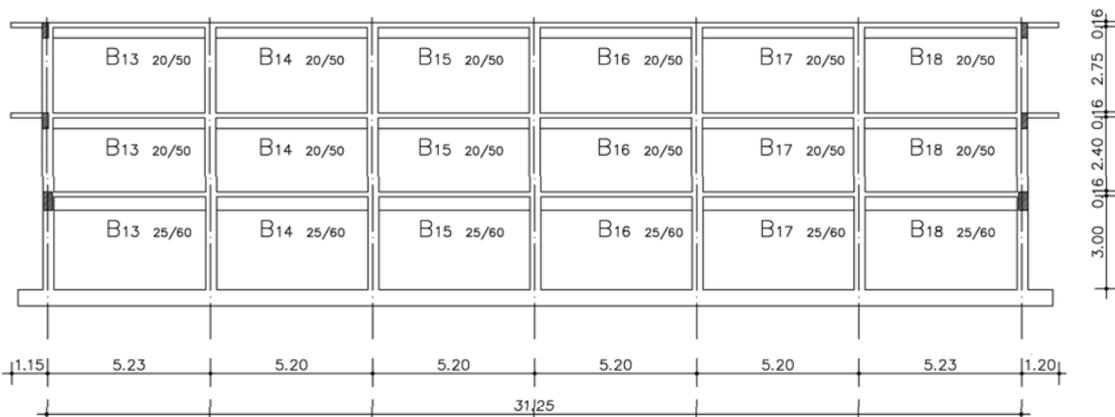
Figure 7: Section 1-1 of the building including foundation.

Observed column damage was concentrated at the heads of columns on the first and second floor; severity varies from light (columns C1, C2, C21 of the 1st floor and C1, C6, C7, C8, C9, C10, C21 of the 2nd floor) to serious (C9, 1st floor and C2, C15, C19, C20, 2nd floor). Nevertheless no total member failures were observed, which can be attributed to sufficient ductility capacity of the columns.
