Simple Strengthening Techniques for Non-engineered Buildings against Seismic Actions

Keywords: Non-engineered buildings, seismic upgrade, seismic strengthening.

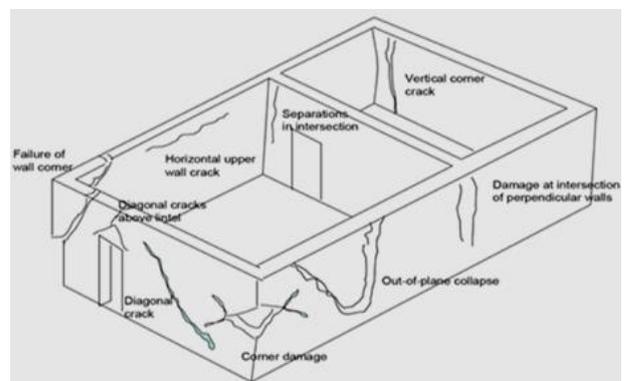
Figure 1. Typical damage in masonry structures

The seismic vulnerable features of masonry buildings include: Weak wall junctions (loss of box action), lack of integrity between load-bearing elements, lack of a diaphragm, long unsupported walls (behaving as cantilever walls), delamination of walls (reduction in load carrying capacity), large and unsymmetrical openings (lack of lateral load resisting elements and torsion effects) and soft-storey effects. Sequences of failure and occurrence of damage types suggest that the factors that govern damage are: (a) Corners are more likely to fail than mid-wall elements, (b) Any panel between two corner failures is unrestrained and is unlikely to remain standing, (c) Non-load bearing panels are more likely to fail than load bearing, (d) Elements generally fail progressively and (e) The failure of one element increases the probability of failure of neighbouring elements. Figure 1 depicts some of these failures.

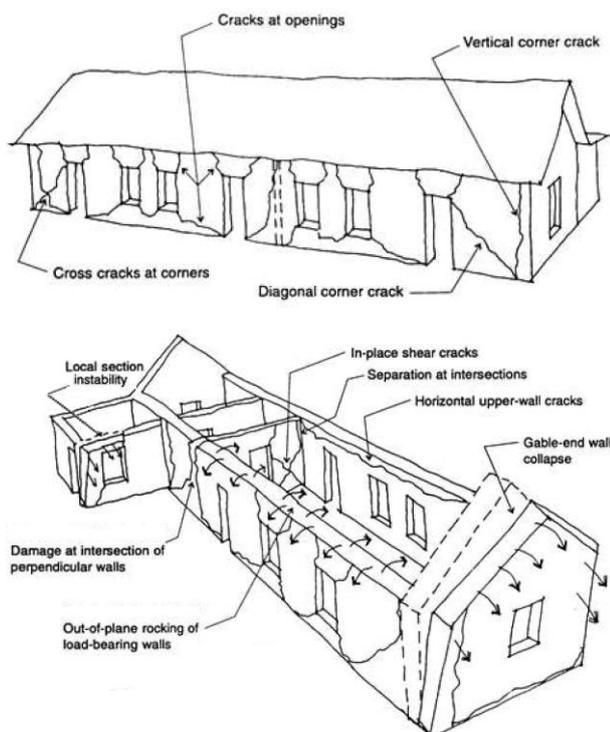
Figure 2. Typical damage in earthen (adobe) structures [2]

Typical types of damage to adobe construction can be summarised by the following: (a) Rocking of independent structural parts and in-plane diagonal and horizontal shear cracks, (b) Shear cracks due to pounding between orthogonal walls, (c) Pediment overturning in gable-end walls, (d) Gable-end wall overturning and possible toe crushing at their base, (e) Diagonal shear cracks in transversal walls. Gable-end wall overturning with portions of transversal walls, (f) Shear failure and sliding of peripheral bracing, (g) Diagonal tensile cracks from out-of-plane bending and diagonal shear cracks in transversal walls, (h) Separation and overturning of small wall segments, (i) Separation and overturning of large wall segments, (j) In plane shear cracks near openings

and masonry piers, (k) Corner dislocation and overturning and (l) Partial disintegration and loss of structural material. Figure 2 presents some of these failures.

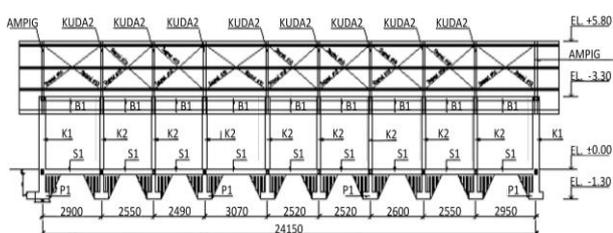
Figure 3. Implementation of new RC frames at a school building in Indonesia [3]

Two types of retrofitting strategies were adopted, depending on the structural capacity of the structures: (a) For the weakest structure, the strengthening approach was to add adequate RC frames on mat footings, as shown in Figure 3, and proper detailing of the connections of structural elements and (b) For the stronger building, the retrofit consisted of applying wire mesh to the infill wall elements and increasing the structural capacity of the foundation through the implementation of double tie beams next to the existing ones (Figure 4). For both structures, proper detailing was applied to the roof truss systems.

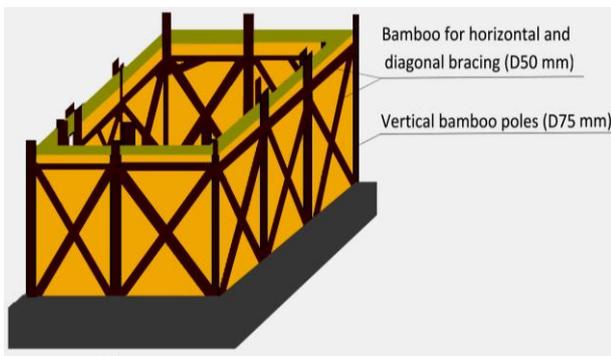
Figure 5. Strengthening of mud houses, [5]

For the improvement of a mud house (Figure 5),

wooden bracing may be used along with metal straps at the connections. However, a good and low cost technique is the insertion of bamboo poles at the inner and outer side of the walls. A concrete plinth may fix the bamboo at the ground level. Then, holes are made through the walls to connect the bamboo poles at the inner and outer sides of the walls using bamboo splints and wire. At the top of the wall, these bamboo poles would be connected using the half bamboo splints in a truss pattern. This provides a lateral force resisting system.

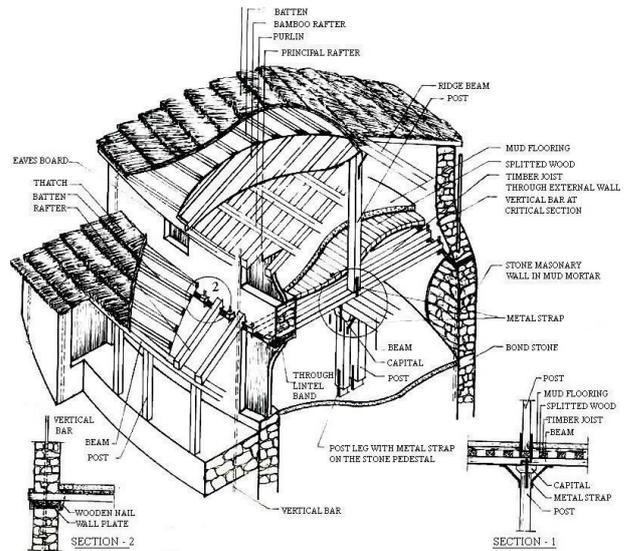
Figure 6. Illustration of simple strengthening techniques in Nepal [6]

Most buildings in Nepal are made of stone and are not engineered since there is no process for Building Code enforcement in rural areas. Therefore, the damage from the 2015 Nepal earthquake was extensive. Simple strengthening techniques (Figure 6) that were suggested [6] comprise of: (a) Roof/floor retrofit with anchorage to walls thus creating diaphragms, (b) Insertion of bond stones in walls, bandages at different levels and splints at critical sections and (c) For timber frames, the creation of bracing (knee bracing, diagonal bracing) in order to strengthen beam-column connections and improving the anchorage of timber columns to the foundation.

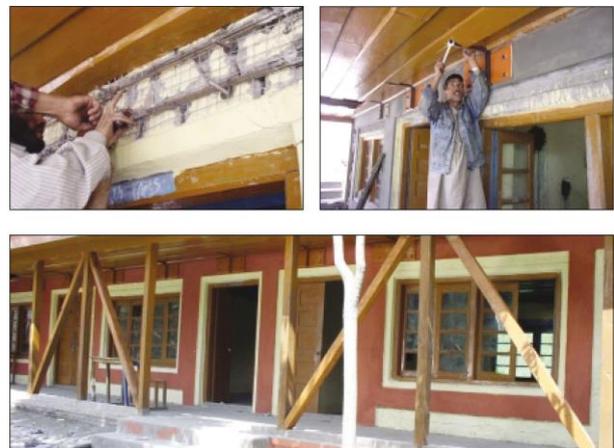
Figure 7. Strengthening with belts, roof anchoring and diagonal timber bracing [7]

The strengthening (Figure 7) included: Installing

vertical reinforcement at inside corners, anchoring the roof which, amongst other things, enforces diaphragm action at the roof level, in-plane bracing at the attic floor level (to reinforce the diaphragm), installing wire mesh to the walls creating reinforced belts on both sides, diagonal timber bracing on the perimeter and encasement of windows with reinforced vertical and horizontal belts.

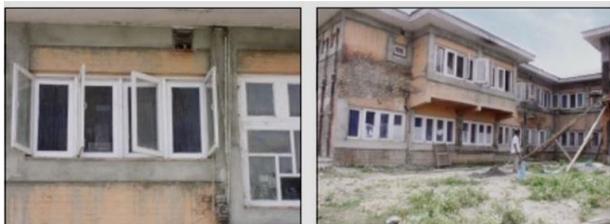
Figure 8. Strengthening with belt encasement around openings [7]

The strengthening of the hospital (Figure 8) consisted of installing vertical reinforcement in the corners, in-plane bracing at the attic floor level, anchoring the roof truss and placing encasement around openings.

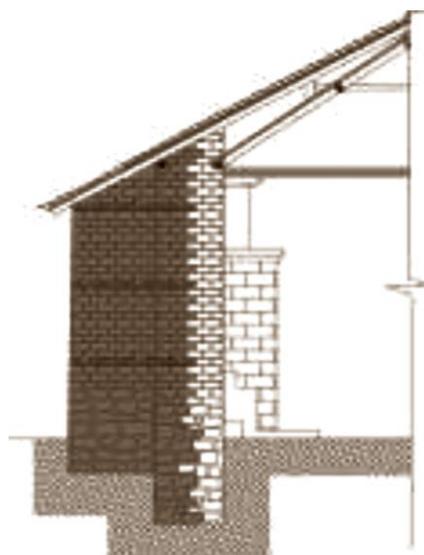
Figure 9. Church of Kuno Tambo, Peru, cross section of new buttress [8]

The strengthening technique that was applied [8] involved placing a combination of buttresses and bracing elements (i.e. corner keys, horizontal keys, bond beams and anchored tie beams). The reestablishment or the addition of buttresses (Figure 9) can efficiently address low or compromised out-of-plane capacity and minimise

lateral deflections, especially in walls of large spans.

Connectivity between the existing earthen walls and the new buttresses can be ensured by inserting horizontal timber elements at various heights. To ensure connectivity and substantial stiffness in corners between orthogonal walls and pillars, orthogonal or diagonal timber keys should be used. The insertion should be made in horizontal planes at various elevations and involve mostly the upper parts of the walls. For existing cracks, several processes that respect the historic fabric can be applicable, such as partial replacement of material, stitching, repointing and grout injections with mud based grouts. Furthermore, additional lateral restraint can be offered by the means of tie beams. This system is placed at the level of the top eaves, embedded across the entire thickness of the walls. It can be subjected to both axial tension and compression, given the dynamic character of seismic loads. Thus, for the system of ties to work both in tension and compression, an adequate anchoring system is needed. A double system of vertical timber anchors, attached close to the interior and exterior surfaces of each wall can be very effective. Finally, the implementation of an internal horizontal timber frame system, at the top level and through the entire thickness of the earthen walls can enhance substantially increase the capacity under lateral forces.
